TECHNICAL INSPECTION REPORT

6 OPERATION CROSSROADS.
U.S.S. CRITTENDEN (APA 77)

TEST ABLE.

VOLUME 2 [U].

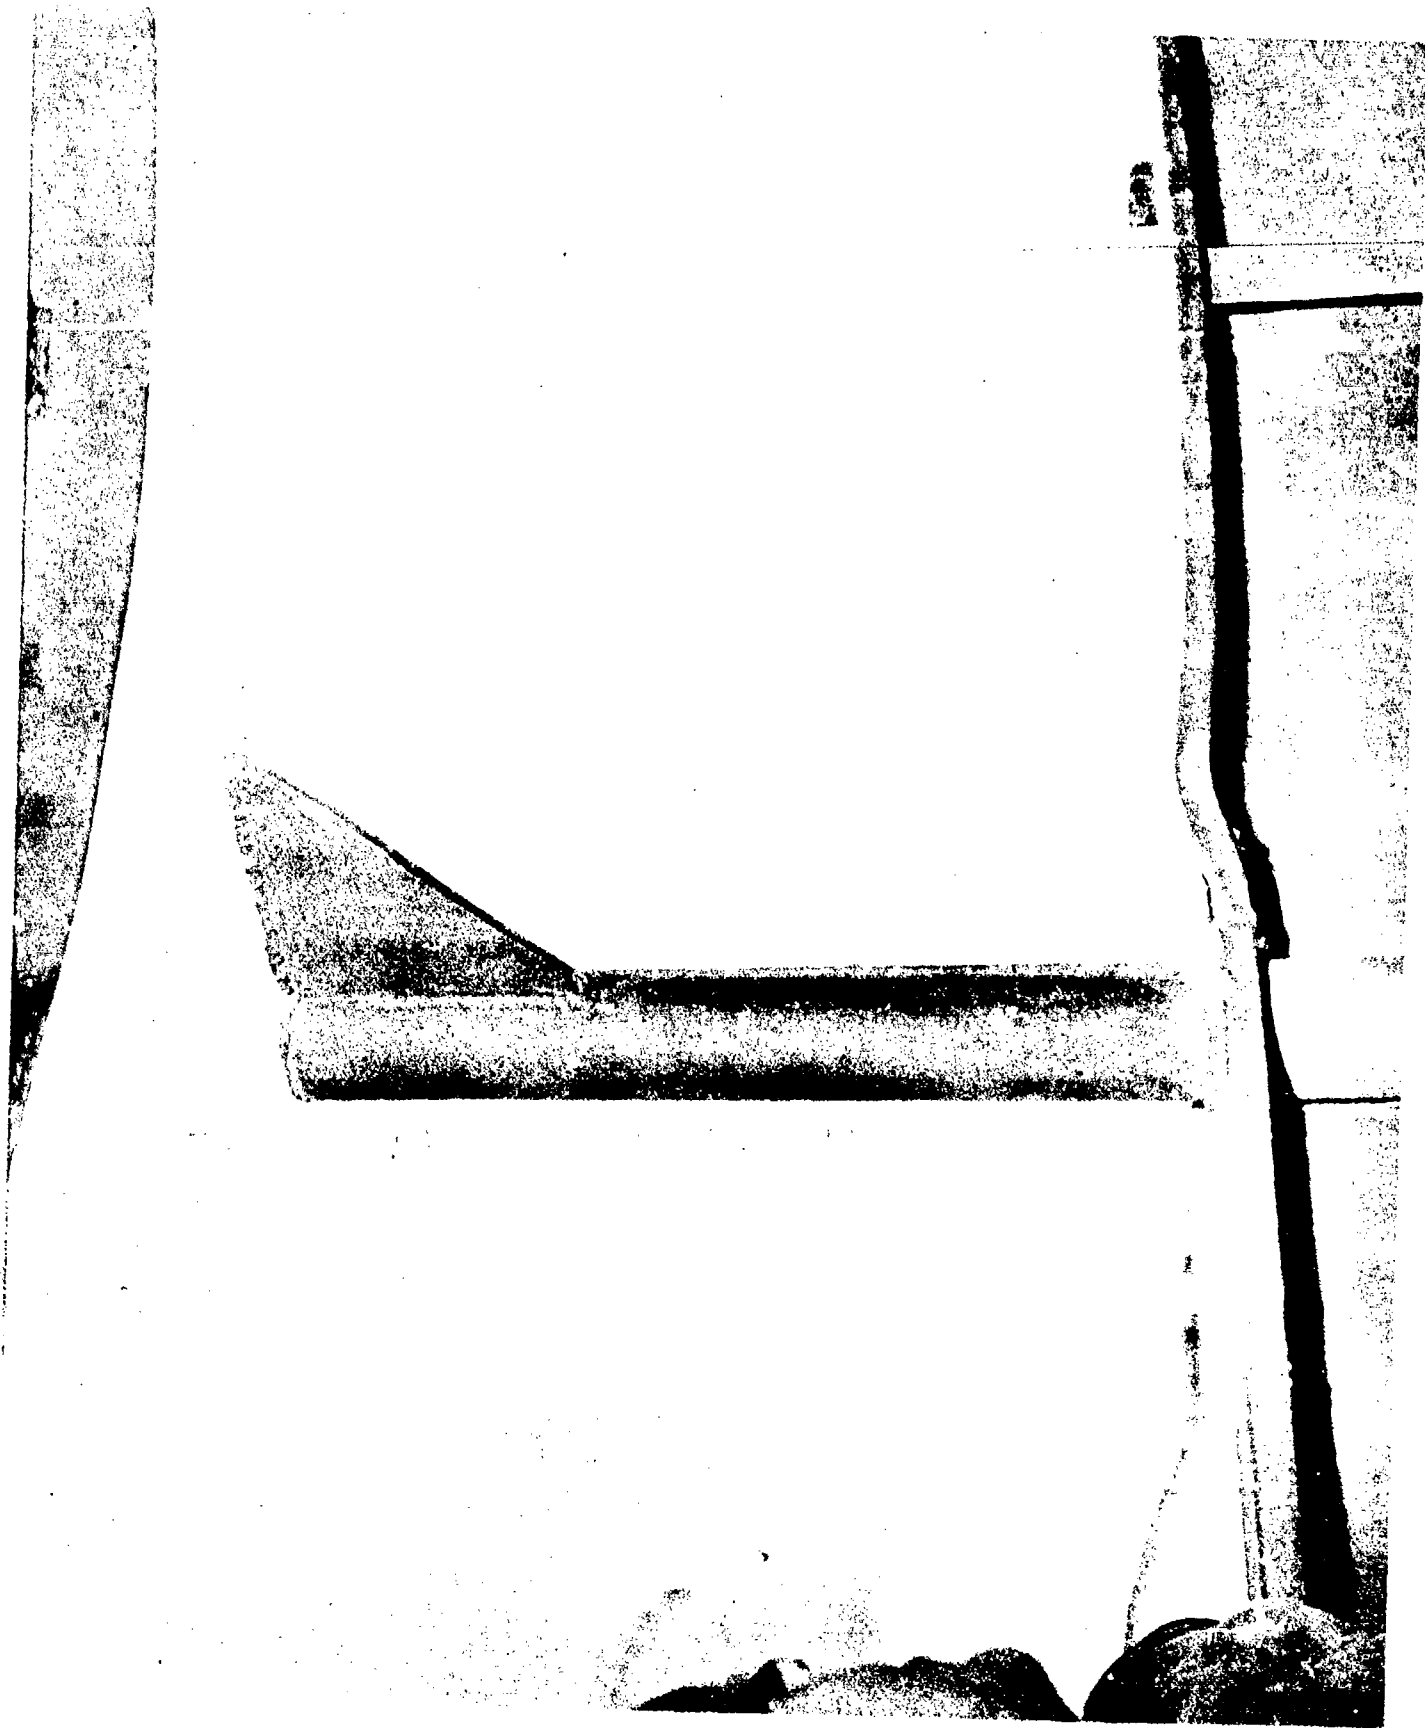
AA-CR-80-1901-7. Looking to port on port wing of navigating bridge showing 10 inch opening between signal bridge structure and supporting stanchion.

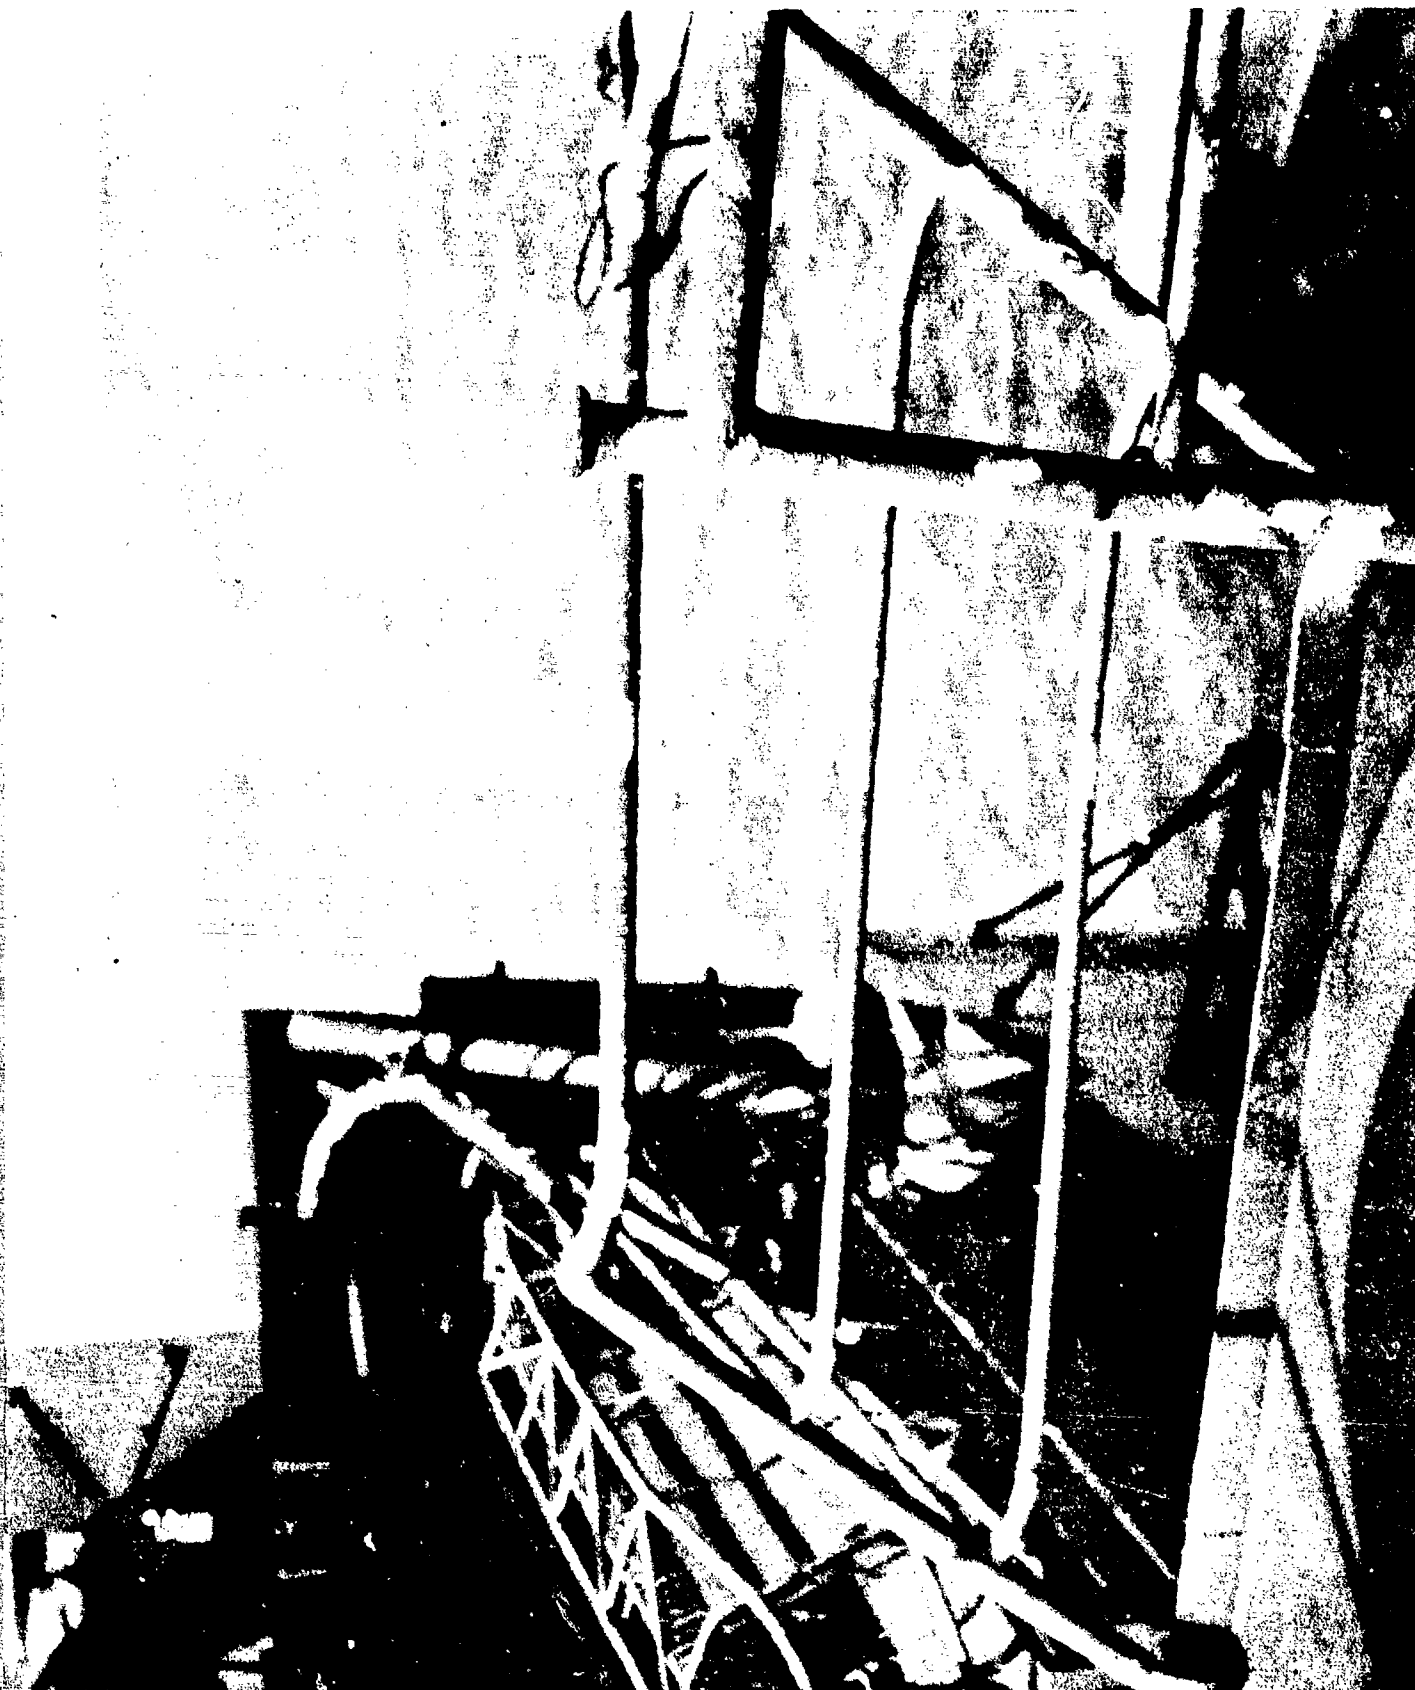
AA-CR-59-2058-8. Looking to starboard and forward on starboard wing of signal bridge showing distortion of railings.

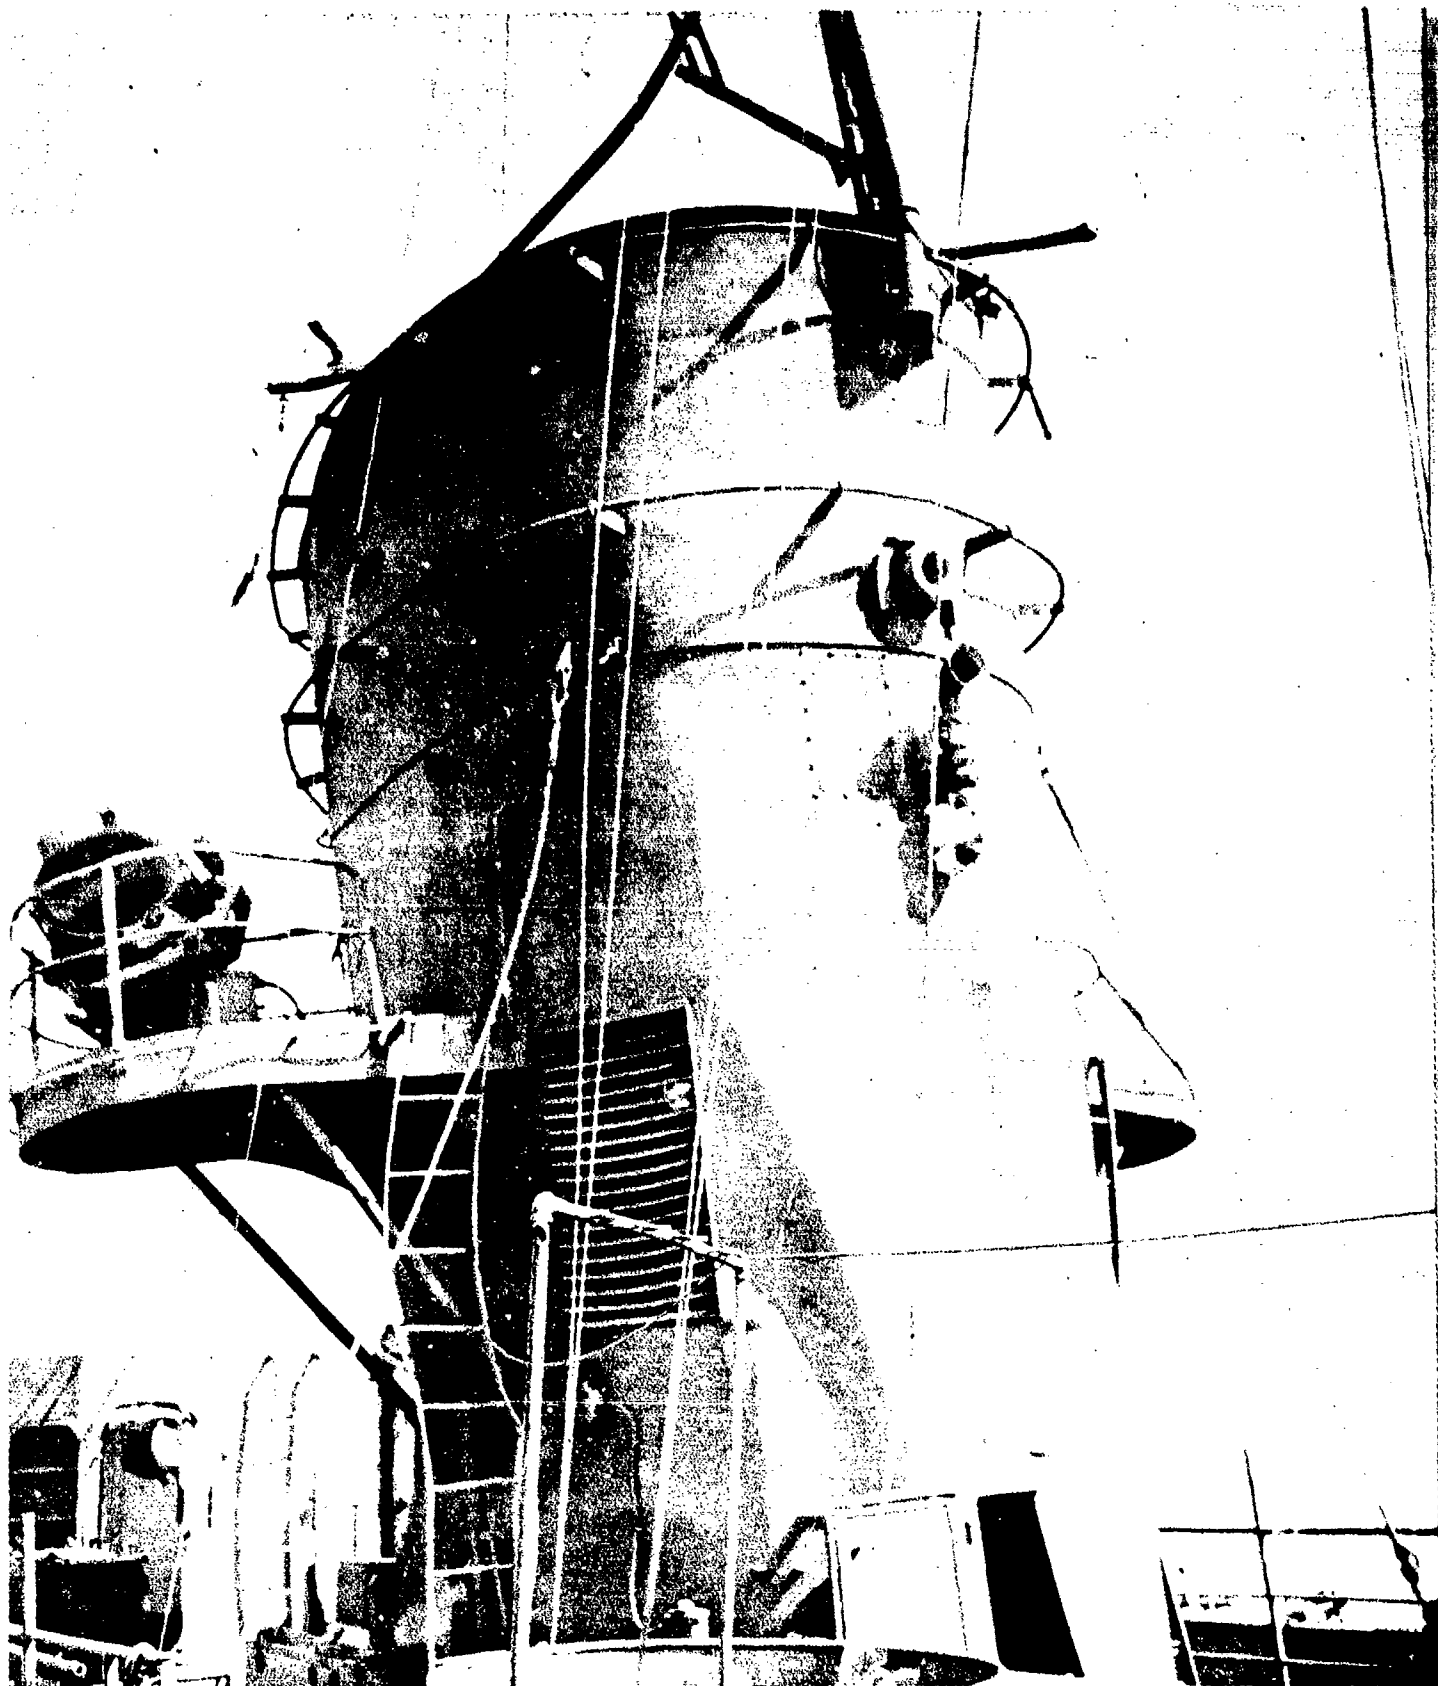
AA-CR-59-2058-9. Looking aft and to port on signal bridge level showing forward and starboard sides of forward stack, Radio direction finder house in background.

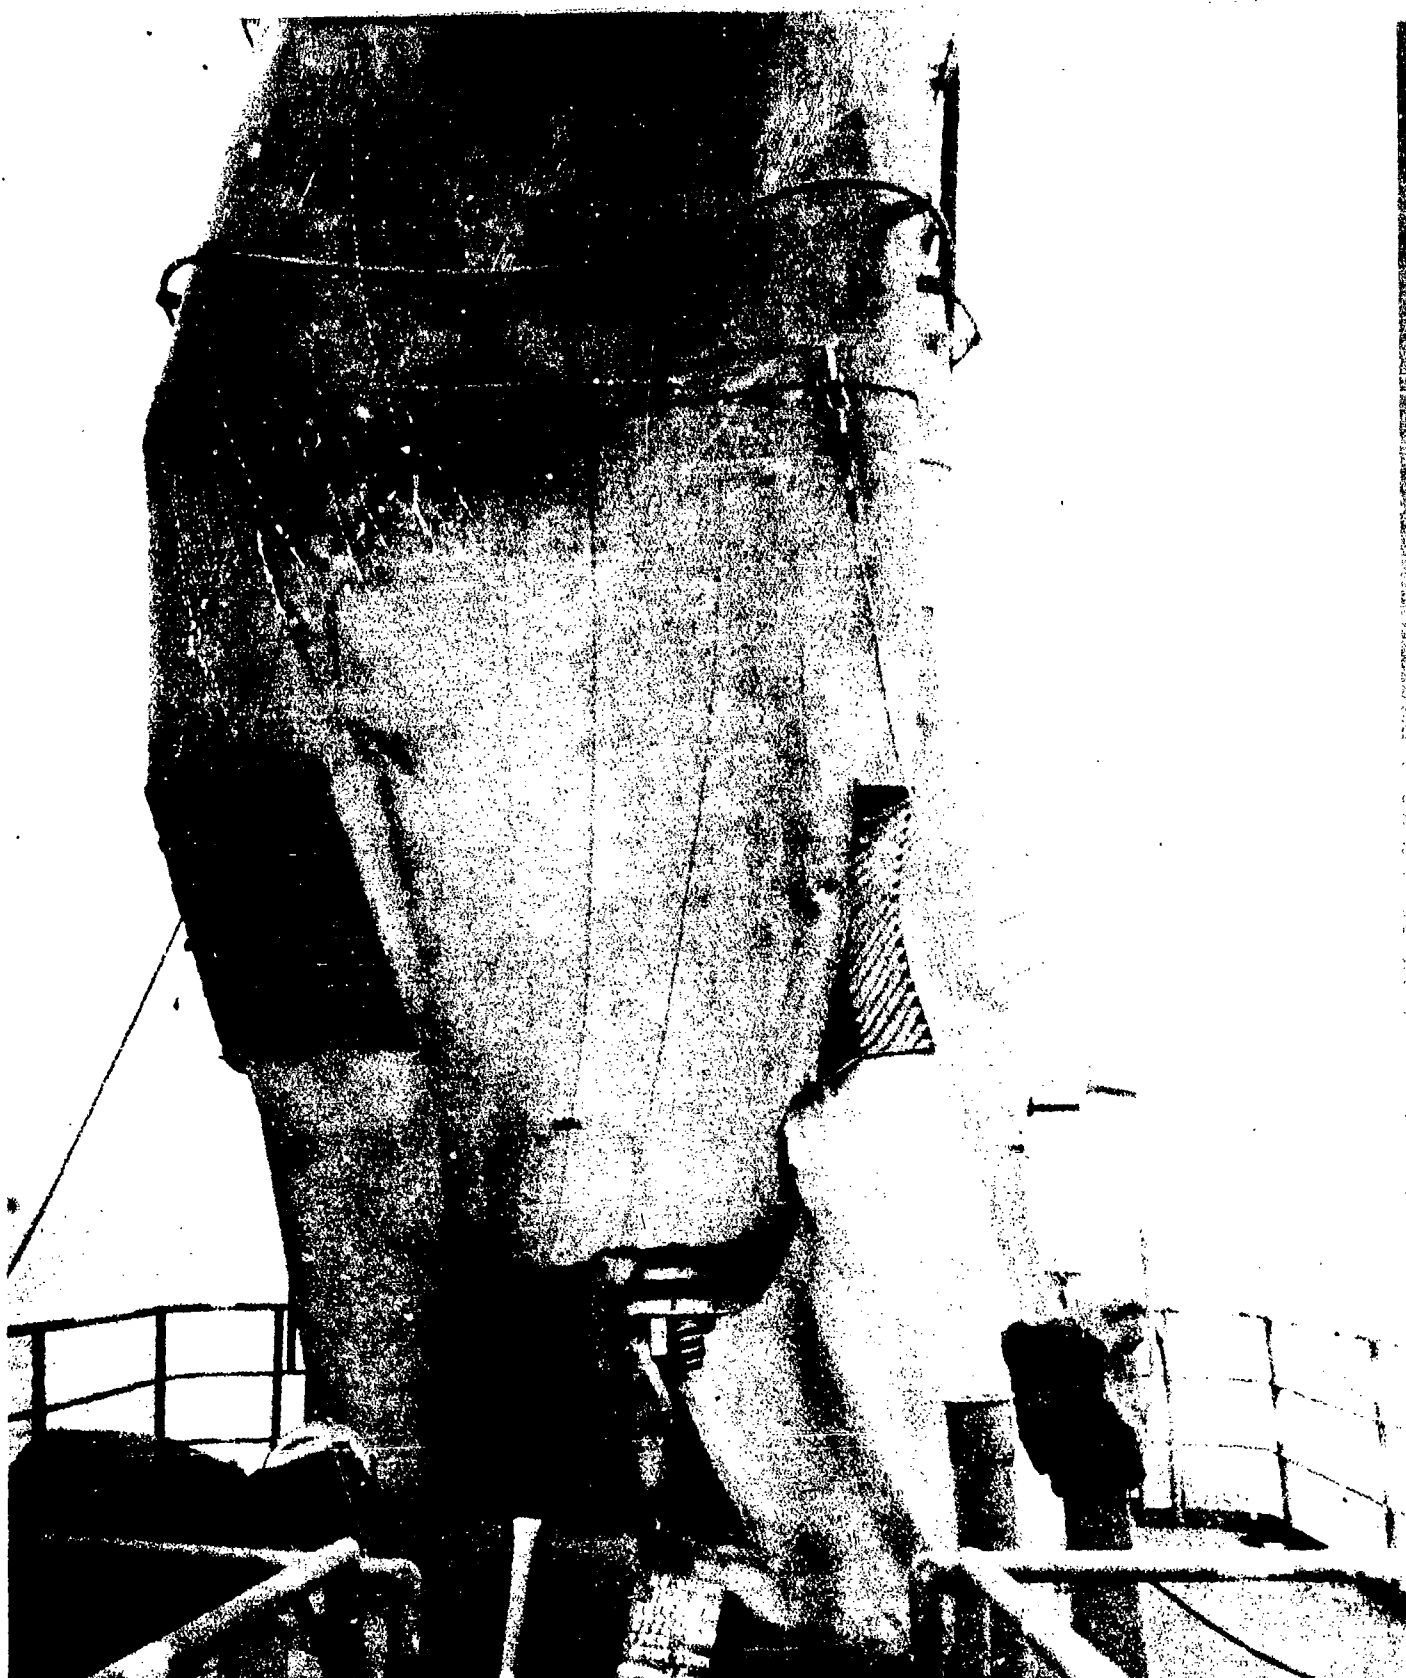
AA-CR-62-1878-4. Looking aft at damage to after stack.

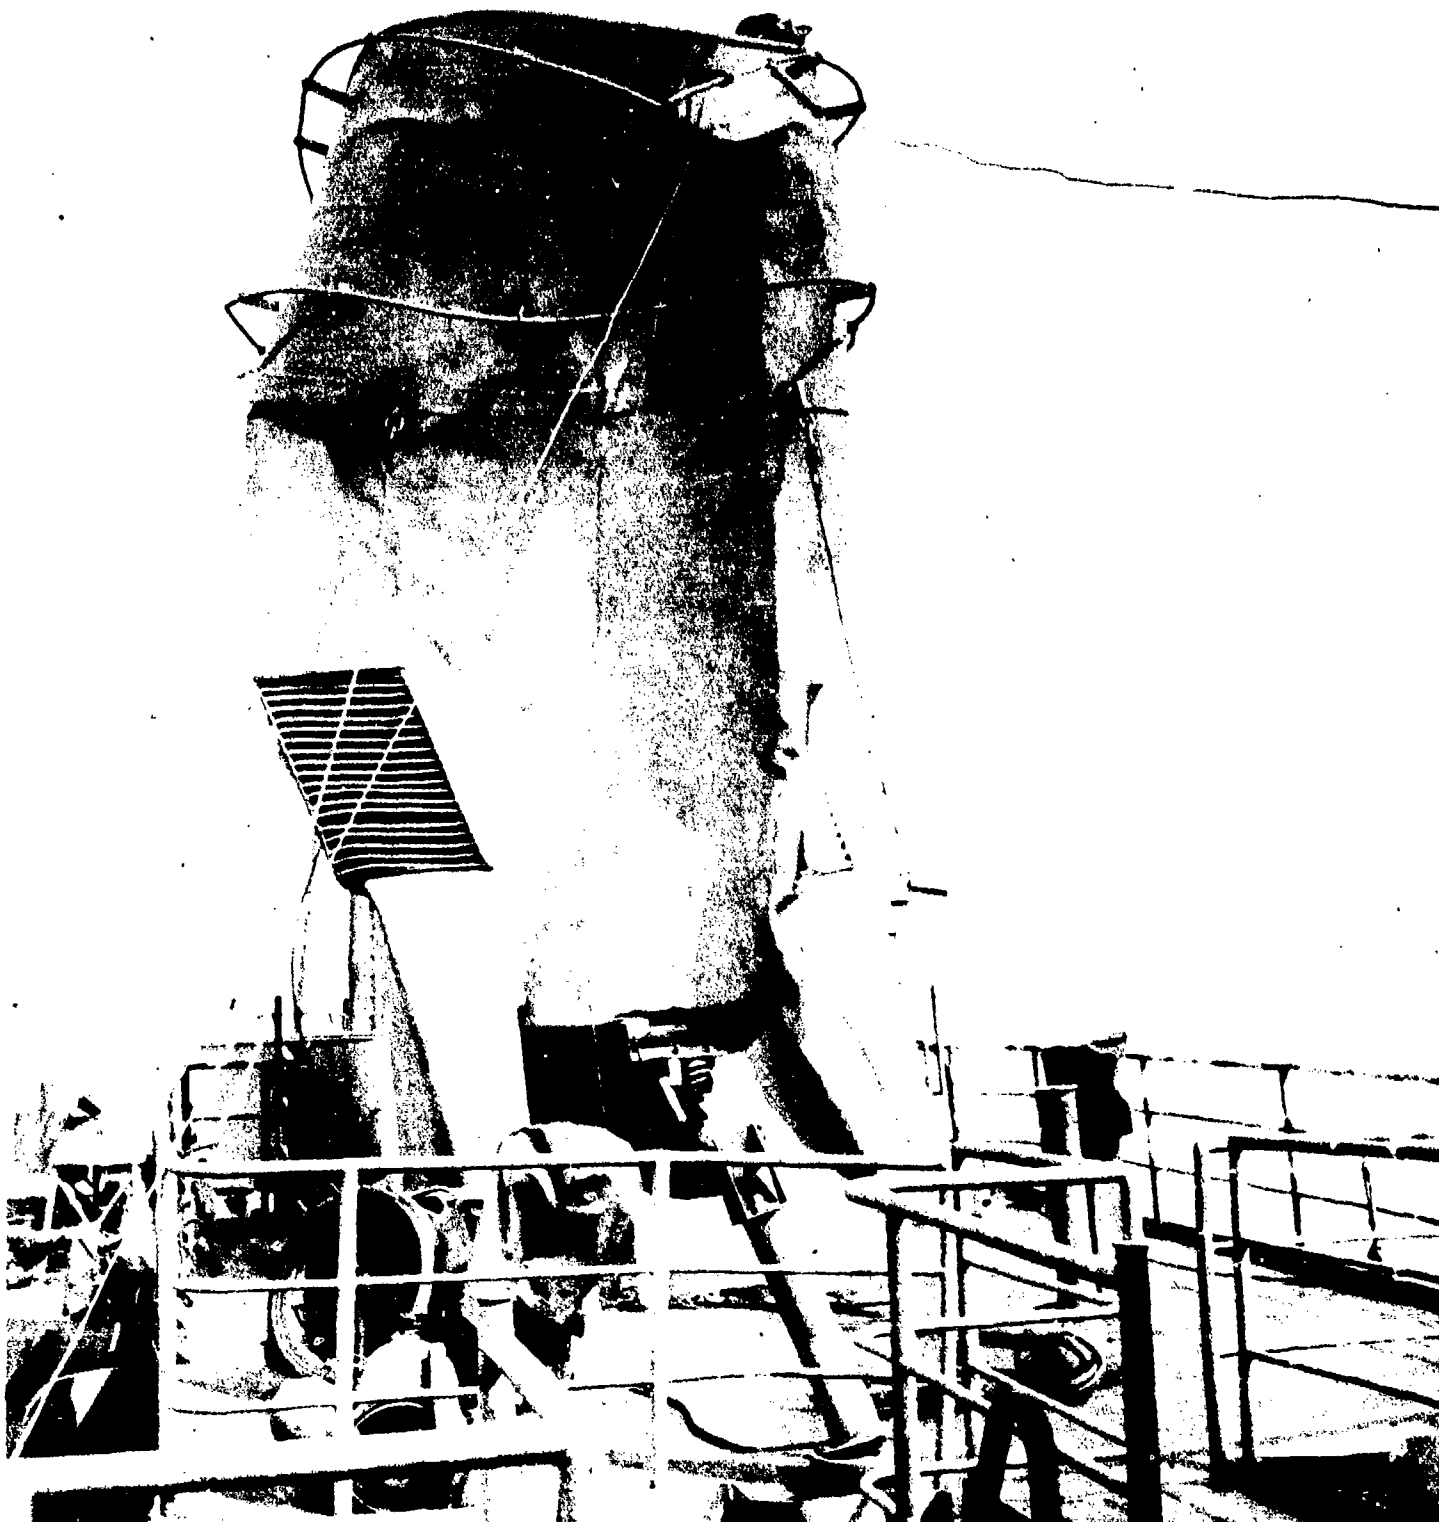
AA-CR-80-1904-6. Looking aft on signal bridge level showing damage to after stack and to instrument pedestals and search light from forward stack. Master compass pedestal is missing.

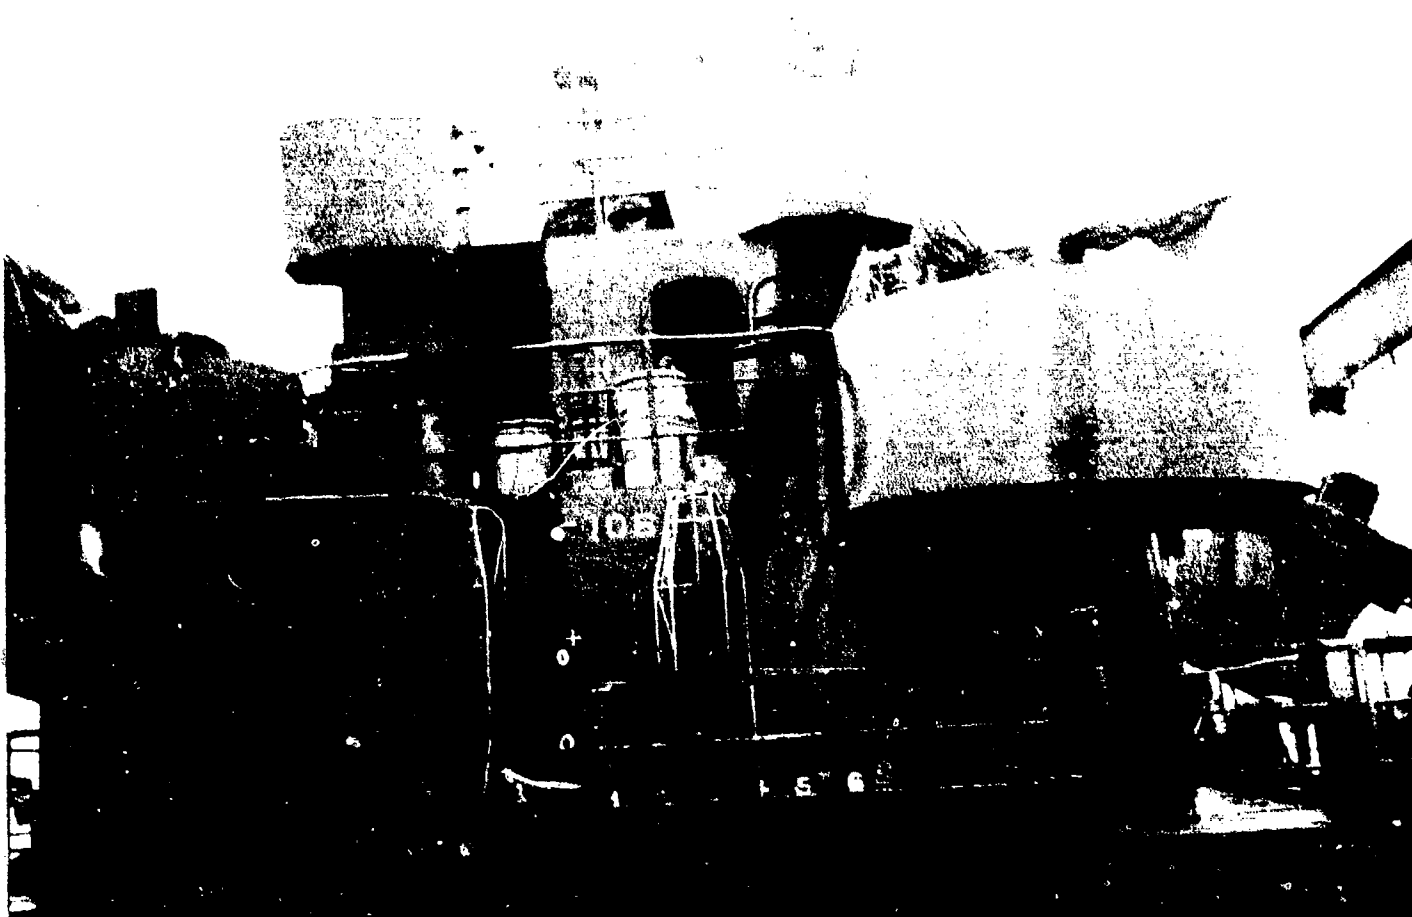
AA-CR-62-1878-7. Looking forward towards damage to after stack and movie projection booth.

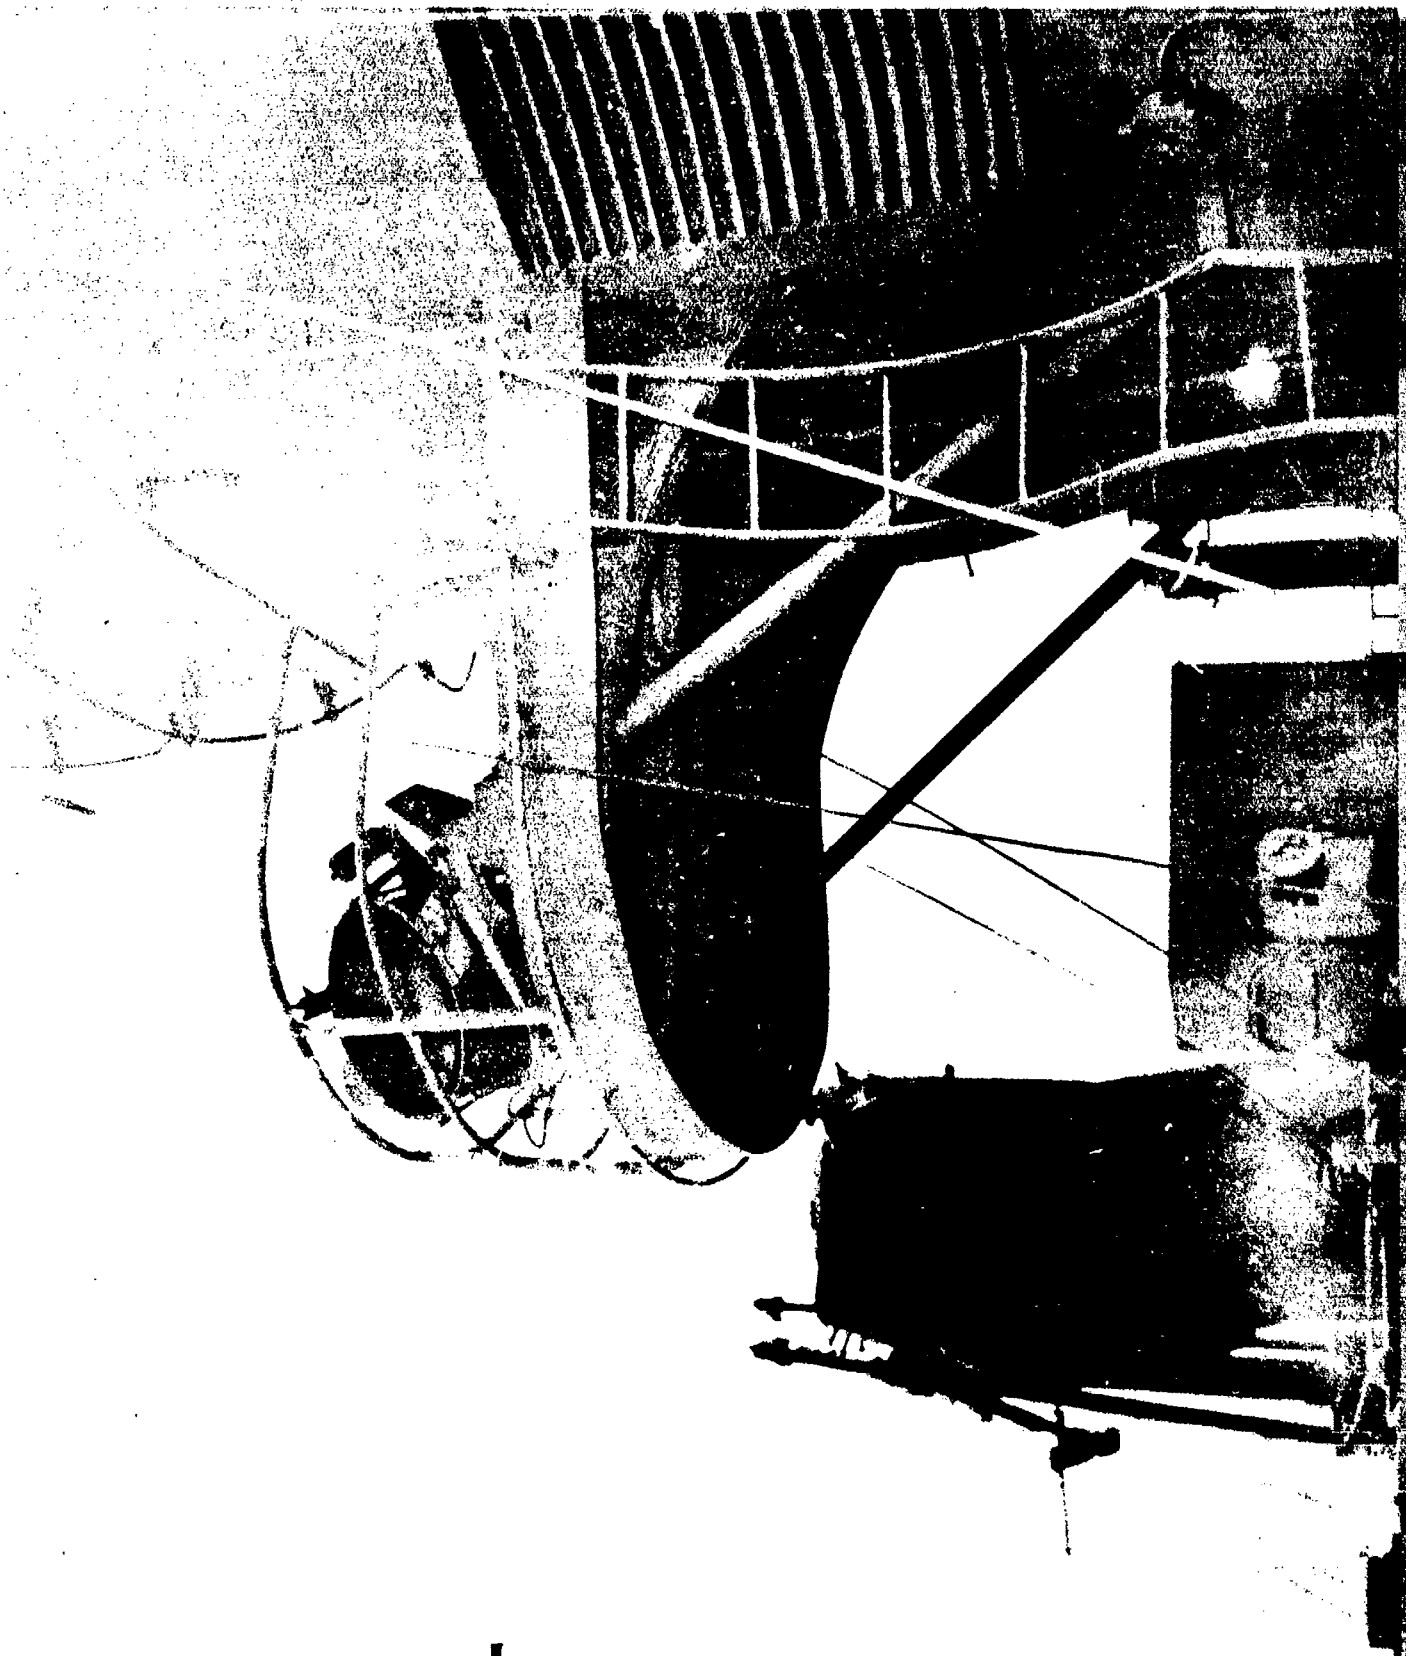
AA-CR-80-1901-5. Looking aft on signal bridge level showing damaged 24 inch searchlight on starboard side of forward stack, and radio direction finder house.

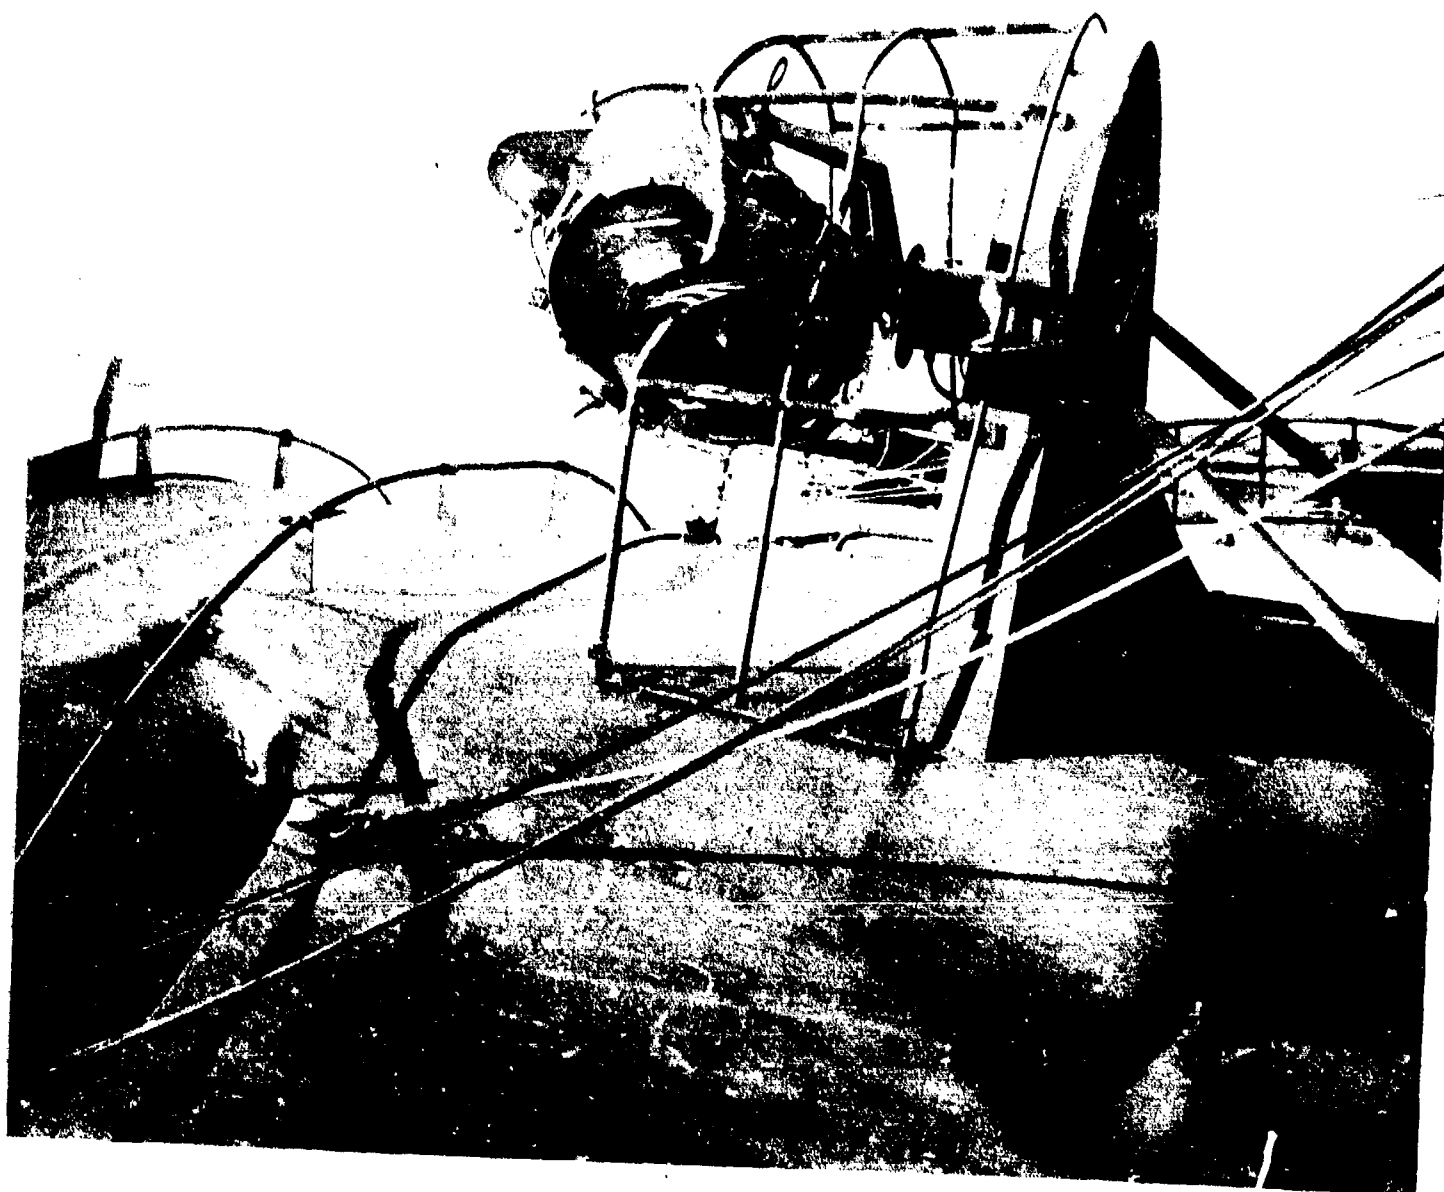
AA-CR-82-1922-5. Looking forward at damaged 24 inch searchlight on starboard side of forward stack.

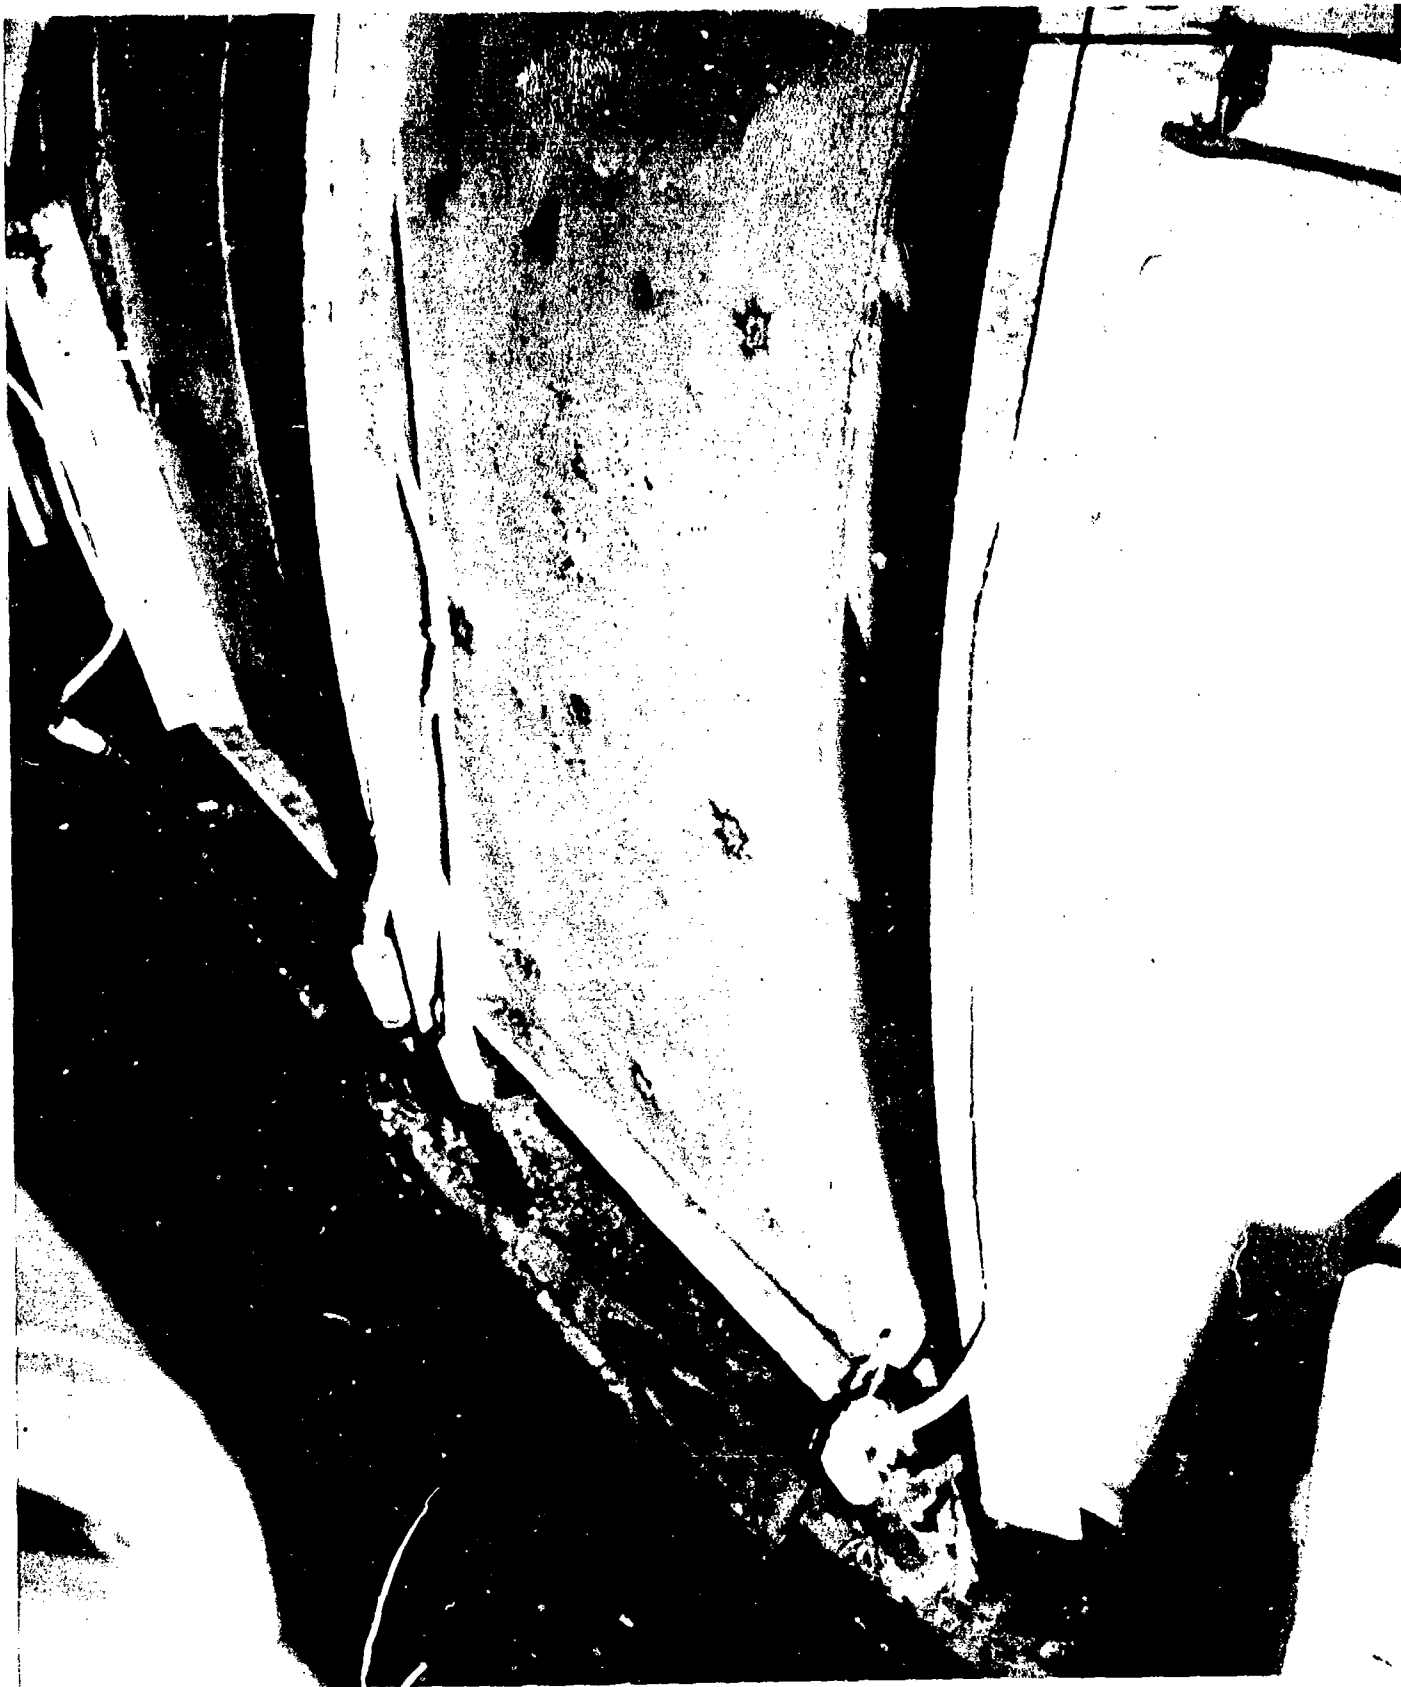
AA-CR-59-2058-3. Looking forward and to port in pilot house showing damage to stiffeners on forward bulkhead.

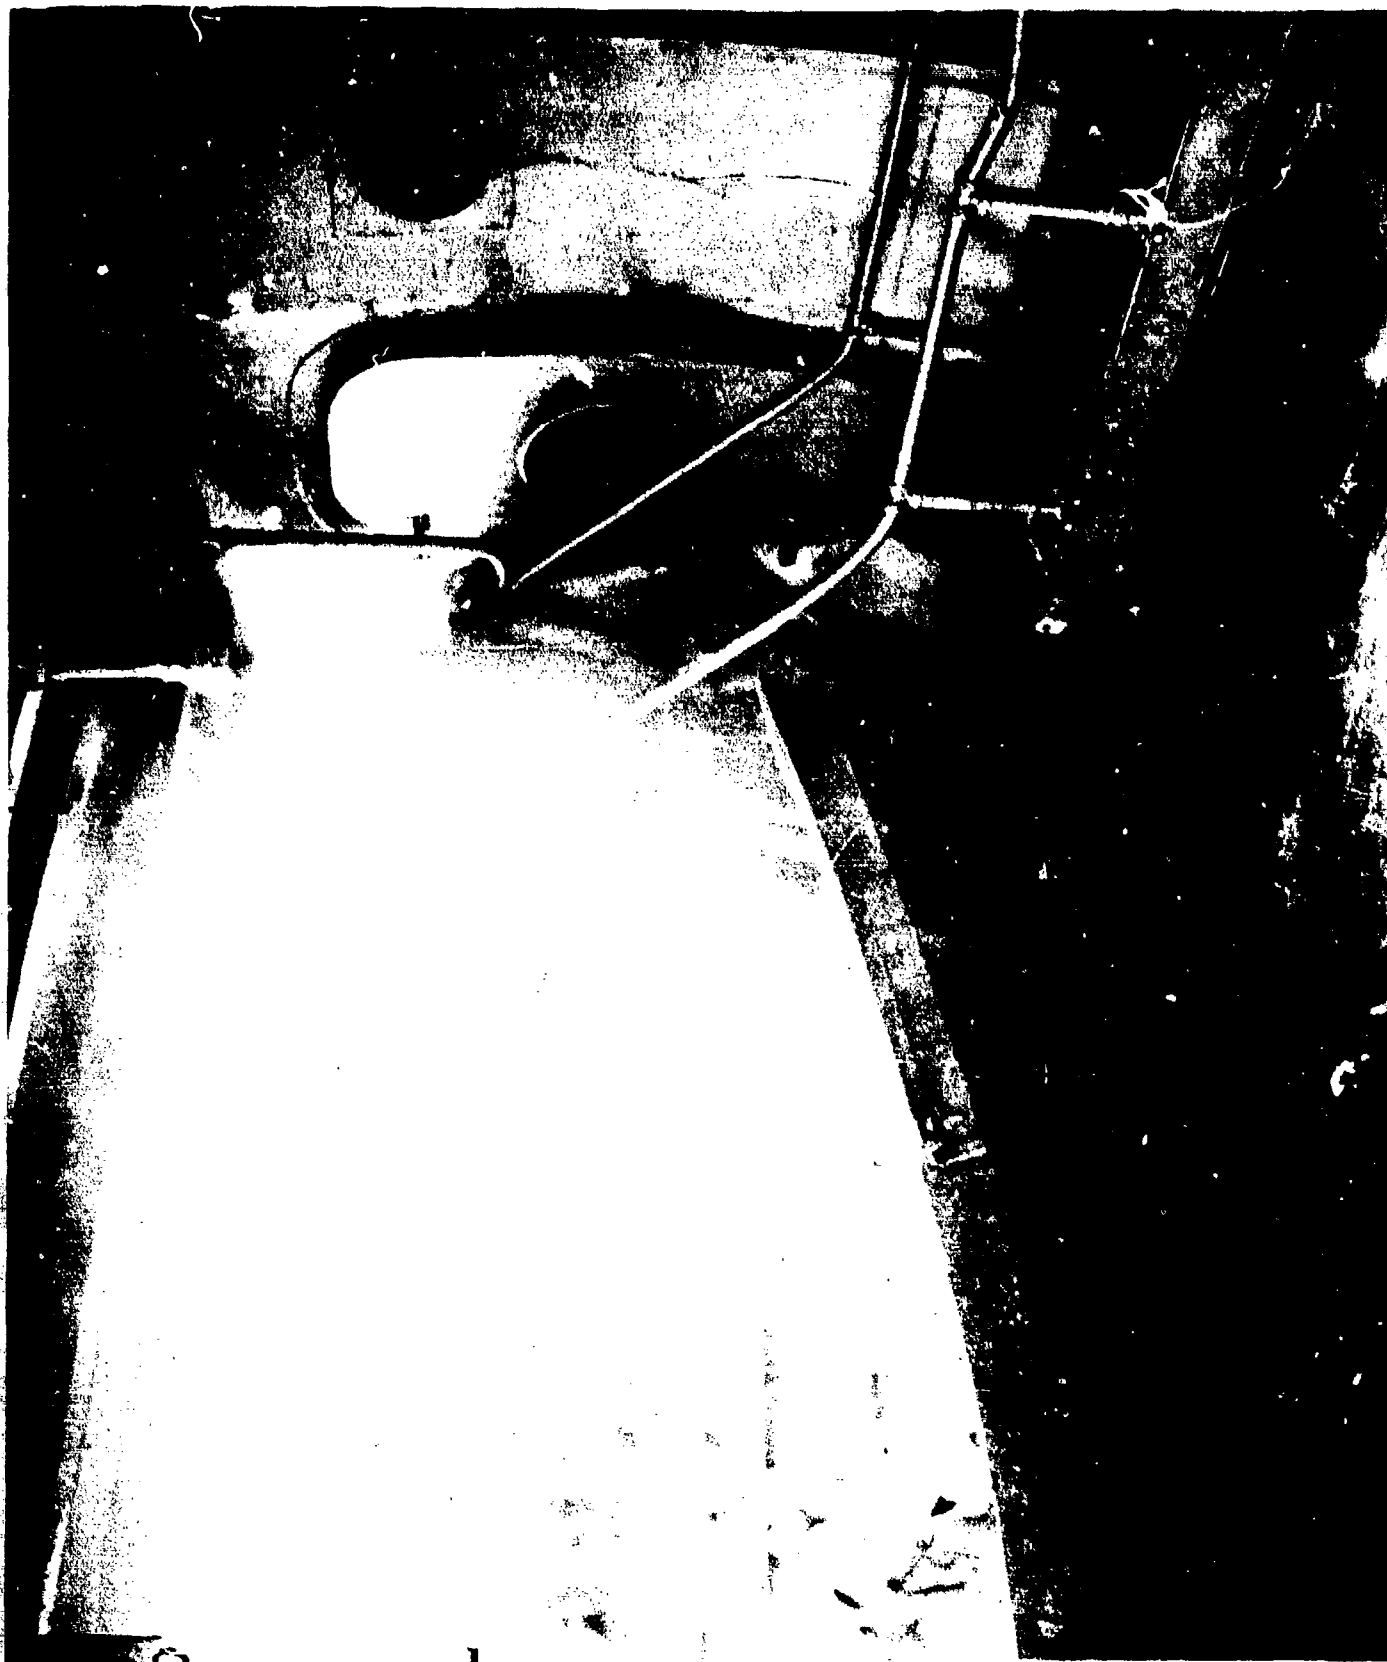
AA-CR-80-1903-10. Looking forward and to starboard on port wing of superstructure deck showing damage to forward bulwark and side of captain's cabin.
